APACHE TRIBE OF OKLAHOMA HOUSING AUTHORITY TRIP REPORT

Assessment of Mold and Moisture Conditions

Final Report

Prepared for:
U.S. Department of Housing & Urban Development
Office of Native American Programs

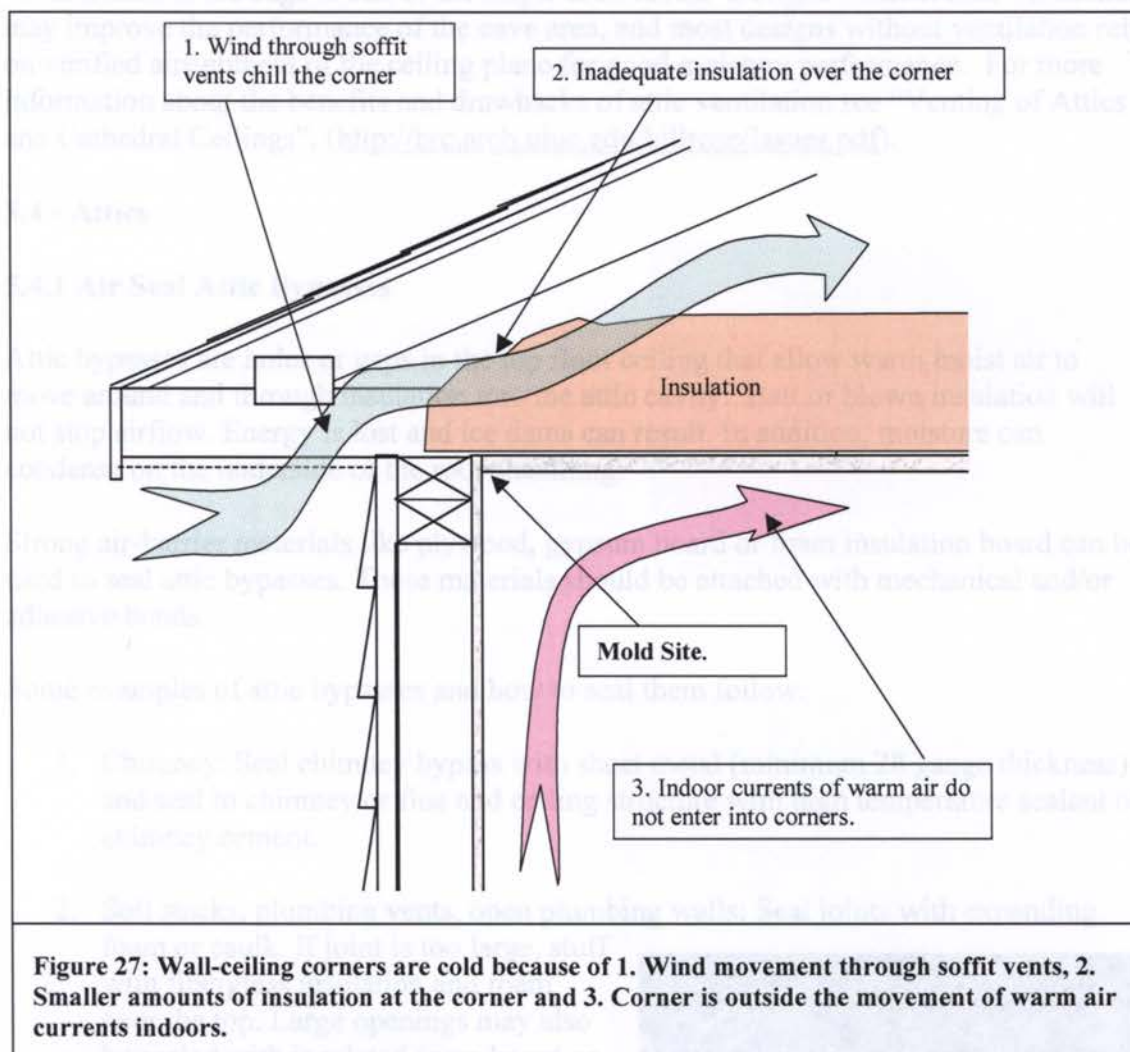
1. Cold wind may enter through soffit vents and pass through the porous insulation material, degrading its thermal performance,
2. The insulation may have been poorly installed resulting in reduced amounts of insulation over the plate, and

3. The geometry of the corner usually means that slow-moving currents of warm air may not be able to reach into the corners (Figure 27).

The dark spots occur where the interior surfaces are the coldest. They occur there because that is the hardest place to insulate effectively. It is difficult to carefully insulate the exterior edge of the attic, especially in homes with low-pitch roofs. With batt insulation, special pusher sticks may be used to get the insulation out to the edge. With loose fill insulation, the outside edge should be prepared correctly so that it is packed with insulation.

Utilizing two-part spray foam over the top plate should provide the necessary R-value and air sealing to warm the interior surface temperature of the wall/ceiling juncture. This measure combined with better indoor relative humidity control (bathroom exhaust fans, venting clothes dryers, resolving site drainage issues) should eliminate any mold problem at this juncture.
